An Analysis of Damaged Wind Turbines by Typhoon Maemi in 2003

Takeshi Ishihara¹⁾, Atsushi Yamaguchi¹⁾, Keiji Takahara²⁾, Takehiro Mekar²⁾ and Shinich Matsuura³⁾

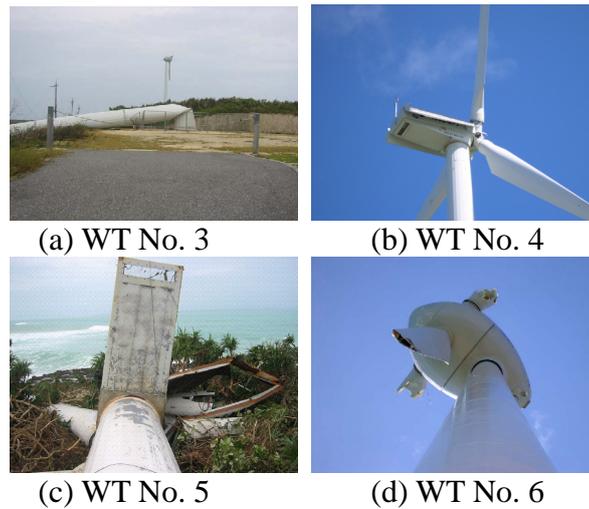
Fig. 7 Damaged wind turbines at Karimata

Table 2 shows the damages on the turbines in detail. WT No.3, 4 and 5 were same machine. WT No.3 and 5 were collapsed by the buckling of the towers near the entrance door. The nacelle cover of WT No.4 was drooped and the nosecone was lost. The two blades of WT No.6 were broken at their roots.

System specifications	Damage
WT No. 3	Manufacturer: Micon Rated power: 400/100kW Regulation: Stall Hub height: 36m	• Collapsed due to the buckling of the tower near the entrance door
WT No. 4	Manufacturer: Micon Rated power: 400/100kW Regulation: Stall Hub height: 36m	• Nacelle cover damaged • Nose cone lost
WT No. 5	Manufacturer: Micon Rated power: 400/100kW Regulation: Stall Hub height: 36m	• Collapsed due to the buckling of the tower near the entrance door
WT No. 6	Manufacturer: Enercon Rated power: 600kW Regulation: Pitch Hub height: 46m	• Blades broken • Nacelle cover damaged

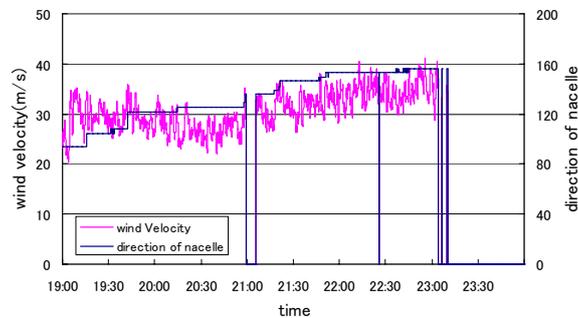
Fig. 8 Time series of yaw direction and the wind speed of turbine No. 5 at Karimata on September 10, 2003

The Micon's turbines were designed with the function that the yaw should be locked with disk-brake after cut-out wind speed. However, it was found that the yaws of WT No.3, 4, 5 were moved clockwise from 94° to 156° when the wind speed exceeded 25 m/s as shown in Fig. 8. As a result, they suffered larger wind load during the typhoon than the designed wind load.

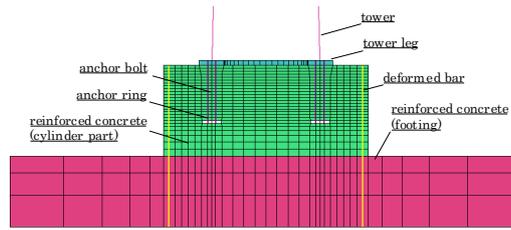
Fig. 16 Foundation model

FEM analysis A FEM analysis with solid elements was performed using the property obtained from material test. The specimens were extracted from the destructed foundation. Fig. 16 shows the foundation model, in which anchor bolts, rings and steel bars were modeled.

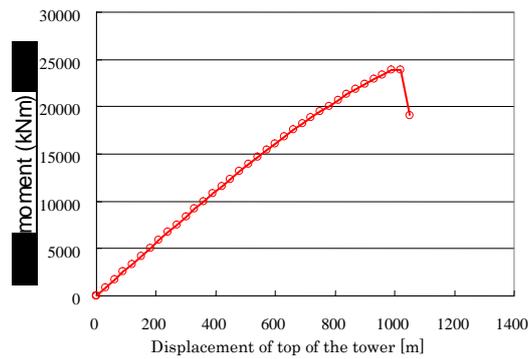
Fig. 17 Relationship between the displacement at the tower top and base bending moment

Fig. 17 shows the relationship between the displacement at the tower top and base bending moment. The ultimate bending moment was 23,864kNm. It was found that the bending moment suddenly falls down at the tower top displacement of 1.0m, the shear strain at which stage is shown in Fig. 18. This indicates that the tenacity of the foundation is low causing easy destruction.

It was found that the maximum bending moment exceeded the ultimate bending moment during the typhoon as shown in table 4.

- (4) The maximum bending moment of the foundation of Nanamata wind turbine No.1 was larger than the ultimate bending moment causing the destruction of the foundation.

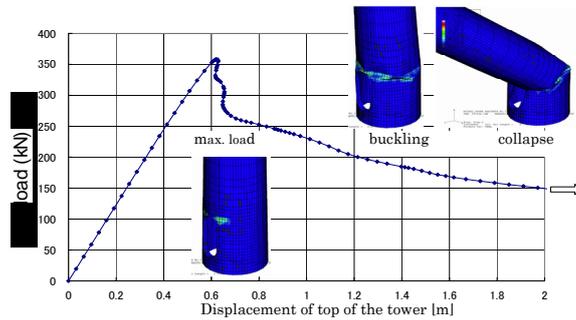
Fig. 20 Load Variables

Fig. 20 shows the relationship between the wind load and the displacement at the tower top. It was found that the horizontal load suddenly falls down at the tower top displacement of 0.6m when the wind load is acting on the opposite side of the entrance door (0°) and that the ultimate bending moment was 12,540kNm.

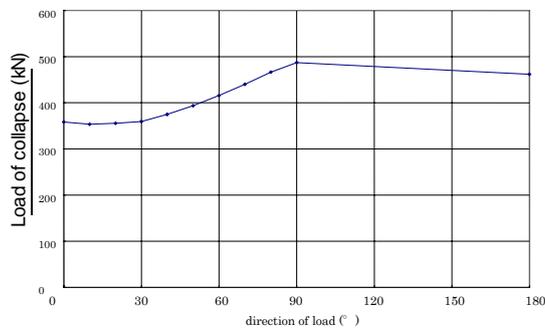
Fig. 21 Buckling Strength Against Direction of Load

Fig. 21 shows the variation of the ultimate load with the direction of wind load. It is obvious that the tower buckles easy when the wind load acts on the tower with the angle ranges from 0° to 40°.

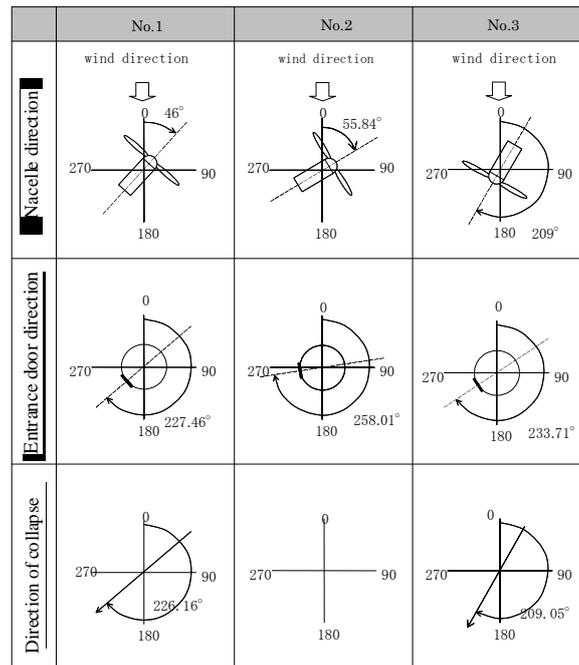
Fig. 22 wind direction, yaw direction and the direction of the entrance door and collapse

Fig. 22 shows the wind direction, yaw direction and the direction of the entrance door and collapse. When the angle between the wind direction and the yaw direction is small, the wind load is large and the tower is likely to buckle when the angle between wind direction and the direction of the door is small.

Table 5 shows the bending moments for each turbine tower. It is obvious that the maximum bending moment for Turbine No. 4 is relatively lower than the values for Turbines No. 3 and 5. This is due to the difference of the nacelle direction among turbines. Despite the fact that all three turbines have the same structure, the maximum bending moment of the wind turbine No.3 and No.5 exceeded ultimate bending moment, while the maximum bending moment of wind turbine No. 4 was lower than the ultimate bending moment. This is why the wind turbine No.3 and No.5 were buckled and collapsed, but wind turbine No. 4 survived during the typhoon.

- (5) The reason for the buckling and the collapse of the tower of Karimata wind turbines No.3 and 5 is that the maximum bending moment of the towers were larger than the ultimate bending moment. The maximum bending moment of wind turbine No. 4 was lower than the ultimate bending moment. This is why the wind turbine No.3 and No.5 were buckled and collapsed, but wind turbine No. 4 survived during the typhoon.
