Damages of wind turbine on Miyakojima Island by Typhoon Maemi in 2003

Keiji TAKAHARA*¹, Takehiro MEKARU*¹, Fumihiko SHINJO*²
Takeshi ISHIHARA*³, Atsushi YAMAGUCHI*³, Shinich MATSUURA*⁴

*1: Research & Development Dept. The Okinawa Electric Power Company

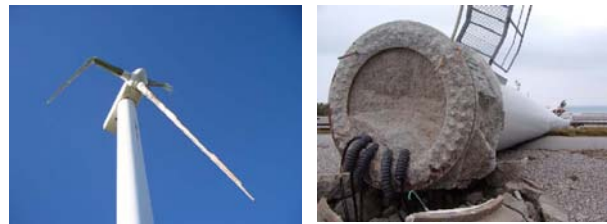
Table 1 shows the damages on the turbines in detail. WT No.1 was collapsed down onto solar power equipment due to foundation destruction, and the blades of WT No.2 were also damaged as shown in Fig. 5.

System specifications	Damage
WT No.1	Manufacturer: Enercon Rated power: 500 kW Regulation: Pitch Hub height: 44m	• Collapsed due to foundation destruction
WT No.2	Manufacturer: Vestas Rated power: 600 kW Regulation: Pitch Hub height: 35m	• Nacelle cover cracked • Blades broken

(a) WT No. 1 (b) WT No. 2
Fig. 5 Damaged turbines at Nanamata

- (4) The maximum bending moment of the foundation of Nanamata wind turbine No.1 was larger than the ultimate bending moment causing the destruction of the foundation.

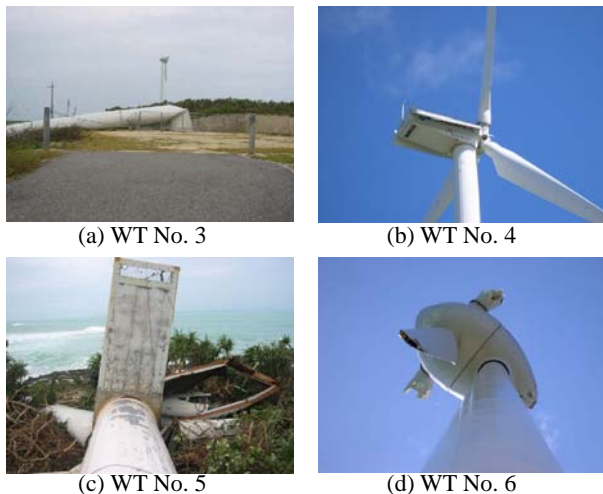
Table 2 shows the damages on the turbines in detail. WT No.3 to 5 were same machine. WT No.3 and 5 were collapsed by the buckling of the towers near the entrance door. The nacelle cover of WT No.4 was drooped and the nosecone was lost. The two blades of WT No.6 were broken at their roots. Fig.7 shows the damaged wind turbines at Karimata.

System specifications	Damage
WT No. 3	Manufacturer: Micon Rated power: 400/100kW Regulation: Stall Hub height: 36m	• Collapsed due to the buckling of the tower near the entrance door
WT No. 4	Manufacturer: Micon Rated power: 400/100kW Regulation: Stall Hub height: 36m	• Nacelle cover drooped • Nose cone lost
WT No. 5	Manufacturer: Micon Rated power: 400/100kW Regulation: Stall Hub height: 36m	• Collapsed due to the buckling of the tower near the entrance door
WT No. 6	Manufacturer: Enercon Rated power: 600kW Regulation: Pitch Hub height: 46m	• Blades broken • Nacelle cover damaged

Fig. 7 Damaged wind turbines at Karimata

- (5) The reason for the buckling and the collapse of the tower of Karimata wind turbines No.3 and 5 is that the maximum bending moment of the towers were larger than the ultimate bending moment. The maximum bending moment of wind turbine No. 4 was lower than the ultimate bending moment. This is why the wind turbine No.3 and No.5 were buckled and collapsed, but wind turbine No. 4 survived during the typhoon.

- (6) Following points were learned and should be useful in wind turbine design in the future: a) the locked yaw can be slipped undesirably; b) the tenacity of the foundation is very low causing the easy destruction; c) some tower have its most weak part at its entrance door, which might cause undesired buckle and collapse of the tower.

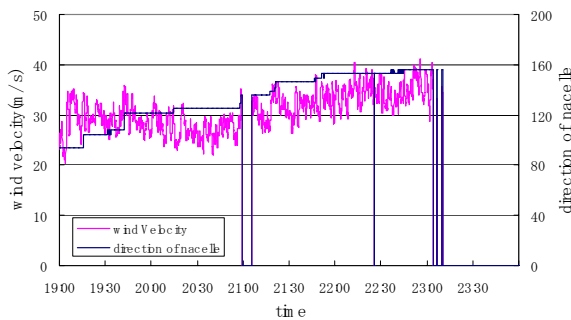
The Micon's turbines were designed with the function that the yaw should be locked with disk-brake after cut-out wind speed. However, it was found that the yaws of WT No.3, 4, 5 were moved clockwise from 94° to 156° when the wind speed exceeded 25 m/s as shown in Fig. 8. As a result, they suffered larger wind load during the typhoon than the designed wind load.

Fig. 8 Time series of yaw direction and the wind speed of turbine No. 5 at Karimata on September 10, 2003

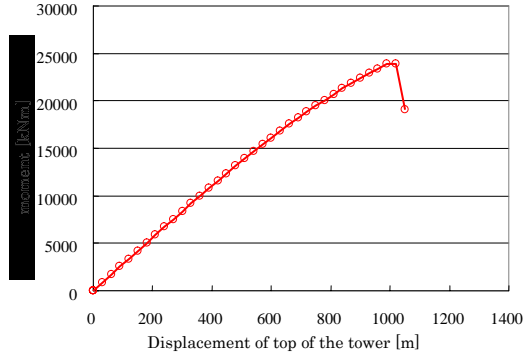
Fig. 16 shows the relationship between the displacement at the tower top and base bending moment. The ultimate bending moment was 23,864kNm. It was found that the bending moment suddenly falls down at the tower top displacement of 1.0m, the shear strain at which stage is shown in Fig. 17. This indicates that the tenacity of the foundation is low causing easy destruction.

Fig. 16 Relationship between the displacement at the tower top and base bending moment

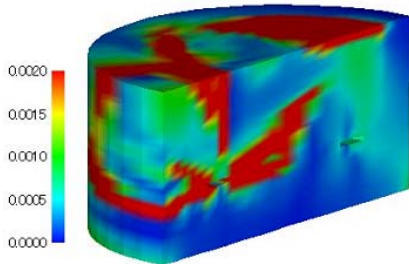
Fig. 17 Perspective view primary shear strain contour

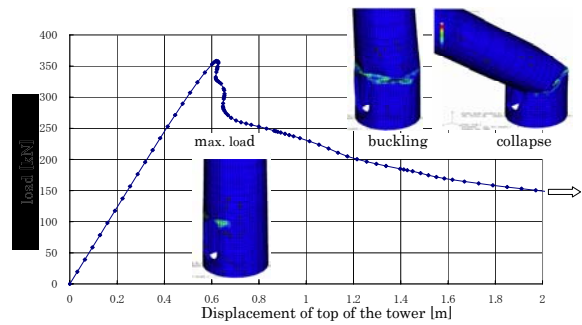
Fig. 19 shows the relationship between the wind load and the displacement at the tower top. It was found that the horizontal load suddenly falls down at the tower top displacement of 0.6m when the wind load is acting on the opposite side of the entrance door (0°) and that the ultimate bending moment was 12,540kNm.

Fig. 19 Load Variables

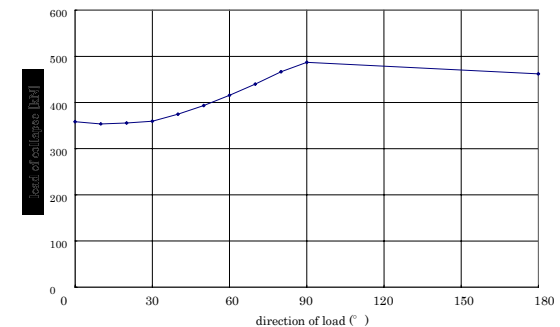
Fig. 20 shows the variation of the ultimate load with the direction of wind load. It is obvious that the tower buckles easy when the wind load acts on the tower with the angle ranges from 0° to 40°.

Fig. 20 Buckling Strength Against Direction of Load

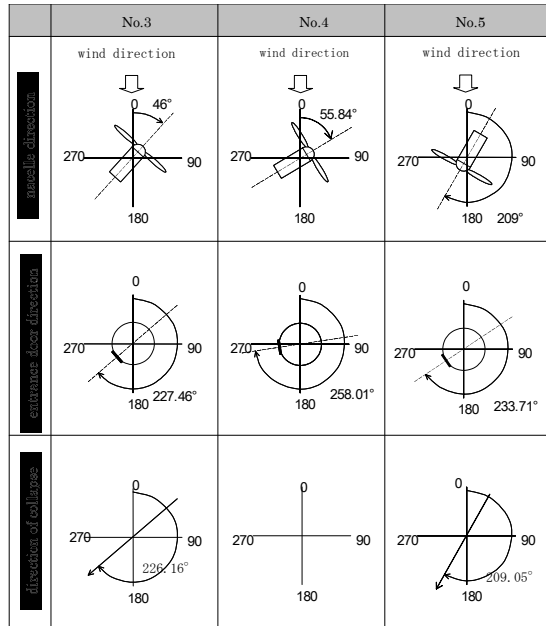
Fig. 21 wind direction, yaw direction and the direction of the entrance door and collapse

Fig. 21 shows the wind direction, yaw direction and the direction of the entrance door and collapse. When the angle between the wind direction and the yaw direction is small, the wind load is large and the tower is likely to buckle when the angle between wind direction and the direction of the door is small.

Table 5 shows the bending moments for each turbine tower. It is obvious that the maximum bending moment for Turbine No. 4 is relatively lower than the values for Turbines No. 3 and No. 5. This is due to the difference of the nacelle direction among turbines. Despite the fact that all three turbines have the same structure, the maximum bending moment of the wind turbine No.3 and No.5 exceeded ultimate bending moment, while the maximum bending moment of wind turbine No. 4 was lower than the ultimate bending moment. This is why the wind turbine No.3 and No.5 were buckled and collapsed, but wind turbine No. 4 survived during the typhoon.
