## **An Analysis of Damaged Wind Turbines by Typhoon Maemi in 2003**

### **ABSTRACT**

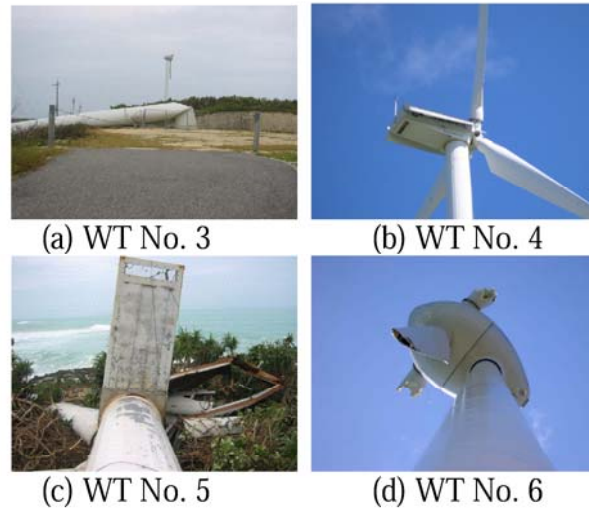
Table 2 shows the damages on the turbines in detail. WT No.3, 4 and 5 were same machine. WT No.3 and 5 were collapsed by the buckling of the towers near the entrance door. The nacelle cover of WT No.4 was drooped and the nosecone was lost. The two blades of WT No.6 were broken at their roots.

| | System specifications | Damage |
|---|---|---|
| WT No. 3 | Manufacturer: Micon<br>Rated power: 400/100kW<br>Regulation: Stall<br>Hub height: 36m | • Collapsed due to the buckling of the tower near the entrance door |
| WT No. 4 | Manufacturer: Micon<br>Rated power: 400/100kW<br>Regulation: Stall<br>Hub height: 36m | • Nacelle cover damaged<br>• Nose cone lost |
| WT No. 5 | Manufacturer: Micon<br>Rated power: 400/100kW<br>Regulation: Stall<br>Hub height: 36m | • Collapsed due to the buckling of the tower near the entrance door |
| WT No. 6 | Manufacturer: Enercon<br>Rated power: 600kW<br>Regulation: Pitch<br>Hub height: 46m | • Blades broken<br>• Nacelle cover damaged |

Fig. 7 Damaged wind turbines at Karimata

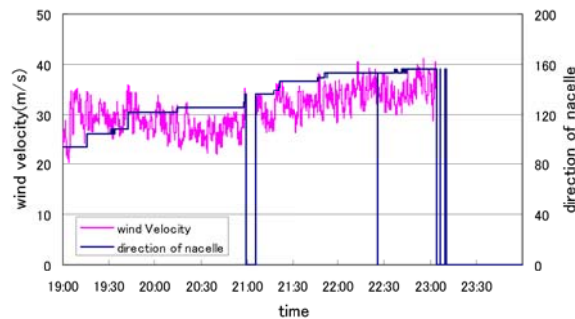
The Micon's turbines were designed with the function that the yaw should be locked with disk-brake after cut-out wind speed. However, it was found that the yaws of WT No.3, 4, 5 were moved clockwise from  $94^\circ$  to  $156^\circ$  when the wind speed exceed 25 m/s as shown in Fig. 8. As a result, they suffered larger wind load during the typhoon than the designed wind load.

Fig. 8 Time series of yaw direction and the wind speed of turbine No. 5 at Karimata on September 10, 2003

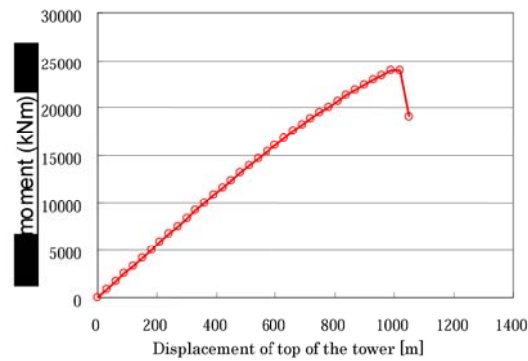
Fig. 17 shows the relationship between the displacement at the tower top and base bending moment. The ultimate bending moment was 23,864kNm. It was found that the bending moment suddenly falls down at the tower top displacement of 1.0m, the shear strain at which stage is shown in Fig. 18. This indicates that the tenacity of the foundation is low causing easy destruction.

Fig. 17 Relationship between the displacement at the tower top and base bending moment

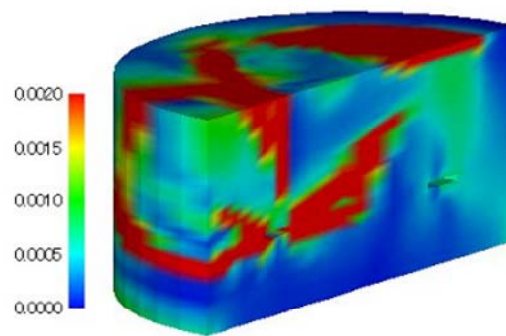
Fig. 18 Perspective view primary shear strain contour

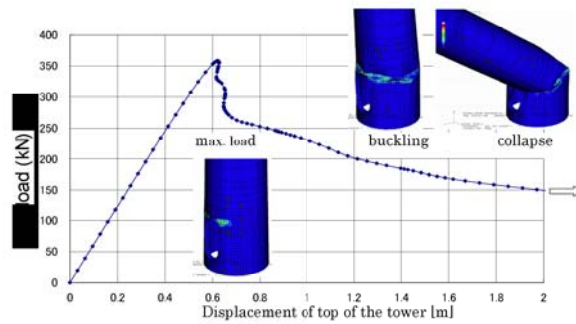
Fig. 20 shows the relationship between the wind load and the displacement at the tower top. It was found that the horizontal load suddenly falls down at the tower top displacement of 0.6m when the wind load is acting on the opposite side of the entrance door (0°) and that the ultimate bending moment was 12,540kNm.

Fig. 20 Load Variables

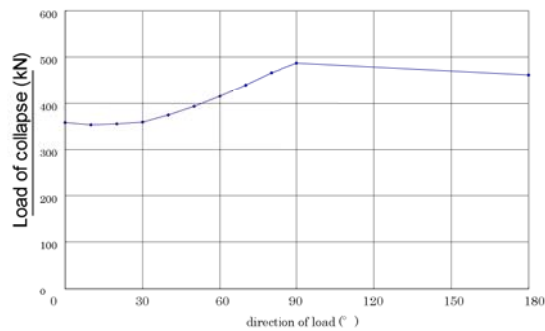
Fig. 21 shoesh the variation of the ultimate load with the direction of wind load. It is obvious that the tower buckles easy when the wind load acts on the tower with the angle ranges from 0° to 40°.

Fig. 21 Buckling Strength Against Direction of Load

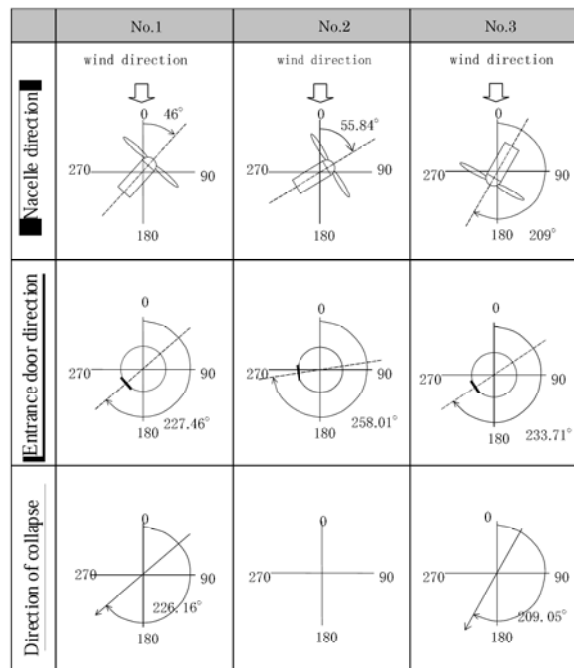
Fig. 22 wind direction, yaw direction and the direction of the entrance door and collapse

Fig. 22 shows the wind direction, yaw direction and the direction of the entrance door and collapse. When the angle between the wind direction and the yaw direction is small, the wind load is large and the tower is likely to buckle when the angle between wind direction and the direction of the door is small.

Table 5 shows the bending moments for each turbine tower. It is obvious that the maximum bending moment for Turbine No. 4 is relatively lower than the values for Turbines No. 3 and 5. This is due to the difference of the nacelle direction among turbines. Despite the fact that all three turbines have the same structure, the maximum bending moment of the wind turbine No.3 and No.5 exceeded ultimate bending moment, while the maximum bending moment of wind turbine No. 4 was lower than the ultimate bending moment. This is why the wind turbine No.3 and No.5 were buckled and collapsed, but wind turbine No. 4 survived during the typhoon.
