An Analysis of Damaged Wind Turbines by Typhoon Maemi in 2003

Takeshi Ishihara¹⁾, Atsushi Yamaguchi¹⁾, Keiji Takahara²⁾, Takehiro Mekar²⁾ and Shinich Matsuura³⁾

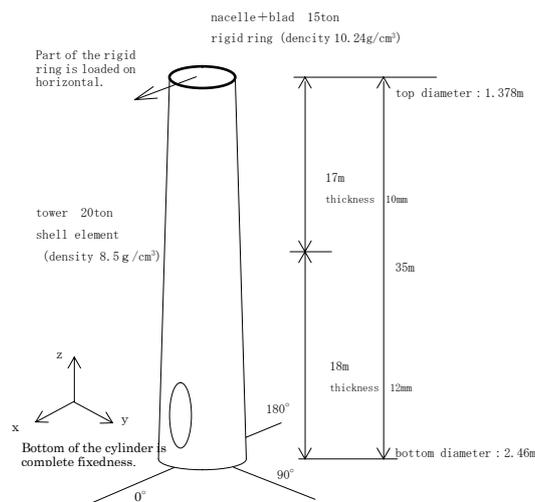
Fig. 19 The notation and the dimension of the tower model

FEM analysis A FEM analysis with shell elements was performed using the property obtained from material test. The specimens were extracted from the collapsed tower. The variations of the ultimate bending moment of the tower with wind direction were evaluated by the horizontal load acting on the top of the tower. Fig. 19 shows the notation and the dimension of the tower model. The thickness of the tower is 10cm at the upper section and 12cm at the lower section. 0 degree denotes the directions of the entrance door.

Fig. 20 shows the relationship between the wind load and the displacement at the tower top. It was found that the horizontal load suddenly falls down at the tower top displacement of 0.6m when the wind load is acting on the opposite side of the entrance door (0°) and that the ultimate bending moment was 12,540kNm.

- (6) Following points were learned and should be useful in wind turbine design in the future: a) the locked yaw can be slipped undesirably; b) the tenacity of the foundation is very low causing the easy destruction; c) some tower have its most weak part at its entrance door, which might cause undesired buckle and collapse of the tower.
