Damages of wind turbine on Miyakojima Island by Typhoon Maemi in 2003

Keiji TAKAHARA*¹, Takehiro MEKARU*¹, Fumihiko SHINJO*²
Takeshi ISHIHARA*³, Atsushi YAMAGUCHI*³, Shinich MATSUURA*⁴

*1: Research & Development Dept. The Okinawa Electric Power Company

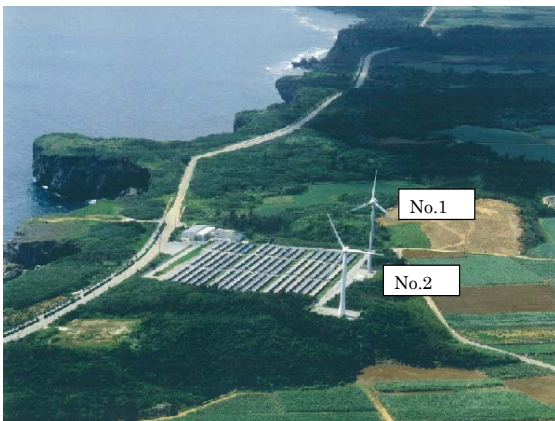
Fig. 4 Turbines at Nanamata before the damage

Fig. 4 shows the Nanamata wind power plant before the damage. Wind Turbine (WT) No. 1 is supplied by Enercon with a rated power of 500 kW and WT No. 2 by Vestas with the rated power of 600 kW. A solar power generation system with a capacity of 750 kW is located at the south to the turbines.

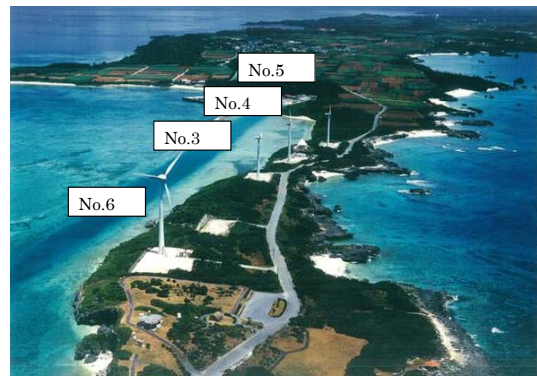
Fig. 6 Turbines at Karimata before the damage

Fig. 6 shows the Karimata wind power plant before the damage. WT No. 3 to 5 is supplied by NEG Micon with a rated power of 400 kW and WT No. 6 by Enercon with the rated power of 600 kW.

Table 2 shows the damages on the turbines in detail. WT No.3 to 5 were same machine. WT No.3 and 5 were collapsed by the buckling of the towers near the entrance door. The nacelle cover of WT No.4 was drooped and the nosecone was lost. The two blades of WT No.6 were broken at their roots. Fig.7 shows the damaged wind turbines at Karimata.

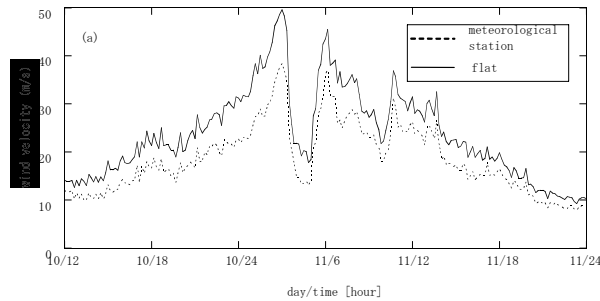
Fig. 11 Wind Velocities Converted for Flat Terrain

Fig. 11 shows the time series of mean wind speed recorded at the meteorological station and estimated one over flat terrain. It was noticed that for northerly wind, the wind speed decreases by the factor of 0.77 at the meteorological station compared to flat terrain. Thus, the maximum wind speed during typhoon is estimated to be 49.6m/s over flat terrain.

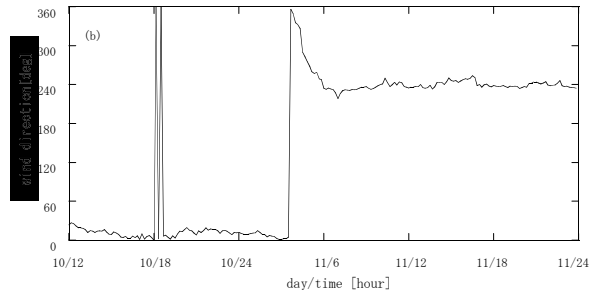
Fig. 12 Wind Directions Changes Across the Flat Terrain

Sudden change in wind direction as shown in Fig. 12 was observed when the center of the typhoon passed right over the island at 3:00 a.m. on the 11th of September, 2003. As a result, the change in the wind direction was 120° from 360° at 3 a.m. to 240° at 6 a.m..

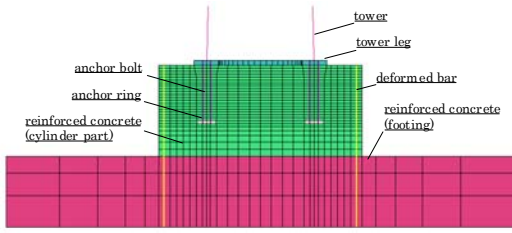
Fig. 15 Foundation model

A FEM analysis with solid elements was performed using the property obtained from material test. The specimens were extracted from the destructed foundation. Fig. 15 shows the foundation model, in which anchor bolts, rings and steel bars were modeled.

Fig. 16 shows the relationship between the displacement at the tower top and base bending moment. The ultimate bending moment was 23,864kNm. It was found that the bending moment suddenly falls down at the tower top displacement of 1.0m, the shear strain at which stage is shown in Fig. 17. This indicates that the tenacity of the foundation is low causing easy destruction.

To clarify the reason why the foundation of turbine No. 1 was destructed, full dynamic simulation was performed using a FEM model with beam elements to estimate the maximum bending moment during the typhoon. The pitch angles of the blades were determined based on the field investigation, which indicated only one blade was feathering.

It was found that the maximum bending moment exceeded the ultimate bending moment during the typhoon as shown in table 4.

- (4) The maximum bending moment of the foundation of Nanamata wind turbine No.1 was larger than the ultimate bending moment causing the destruction of the foundation.

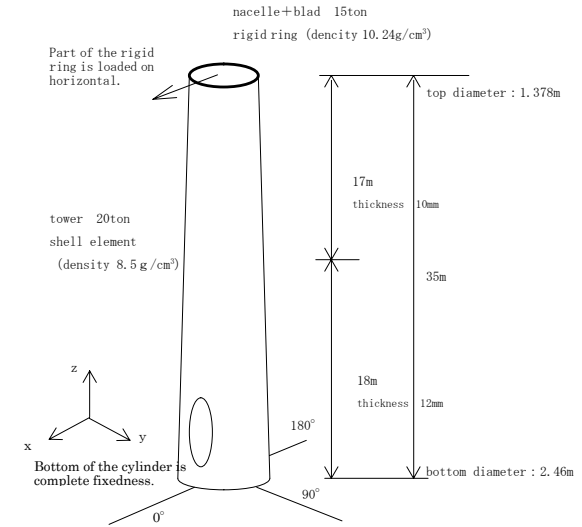
Fig. 18 The notation and the dimension of the tower model

with wind direction were evaluated by the horizontal load acting on the top of the tower. Fig. 18 shows the notation and the dimension of the tower model. The thickness of the tower is 10mm at the upper section and 12mm at the lower section. 0 degree denotes the directions of the entrance door.

Fig. 19 shows the relationship between the wind load and the displacement at the tower top. It was found that the horizontal load suddenly falls down at the tower top displacement of 0.6m when the wind load is acting on the opposite side of the entrance door (0°) and that the ultimate bending moment was 12,540kNm.

Fig. 20 shows the variation of the ultimate load with the direction of wind load. It is obvious that the tower buckles easy when the wind load acts on the tower with the angle ranges from 0° to 40°.

- (6) Following points were learned and should be useful in wind turbine design in the future: a) the locked yaw can be slipped undesirably; b) the tenacity of the foundation is very low causing the easy destruction; c) some tower have its most weak part at its entrance door, which might cause undesired buckle and collapse of the tower.
