## **An Analysis of Damaged Wind Turbines by Typhoon Maemi in 2003**

### **ABSTRACT**

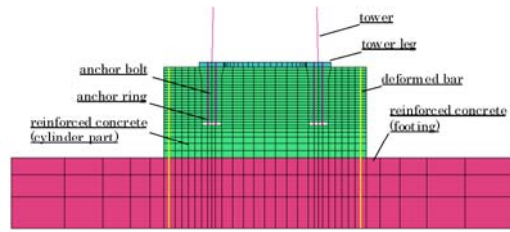
Fig. 16 Foundation model

FEM analysis A FEM analysis with solid elements was performed using the property obtained from material test. The specimens were extracted from the destructed foundation. Fig. 16 shows the foundation model, in which anchor bolts, rings and steel bars were modeled.

Fig. 17 shows the relationship between the displacement at the tower top and base bending moment. The ultimate bending moment was 23,864kNm. It was found that the bending moment suddenly falls down at the tower top displacement of 1.0m, the shear strain at which stage is shown in Fig. 18. This indicates that the tenacity of the foundation is low causing easy destruction.

- (4) The maximum bending moment of the foundation of Nanamata wind turbine No.1 was larger than the ultimate bending moment causing the destruction of the foundation.

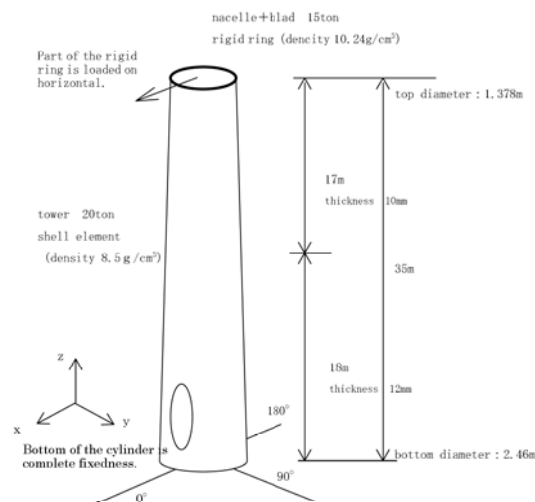
Fig. 19 The notation and the dimension of the tower model

FEM analysis A FEM analysis with shell elements was performed using the property obtained from material test. The specimens were extracted from the collapsed tower. The variations of the ultimate bending moment of the tower with wind direction were evaluated by the horizontal load acting on the top of the tower. Fig. 19 shows the notation and the dimension of the tower model. The thickness of the tower is 10cm at the upper section and 12cm at the lower section. 0 degree denotes the directions of the entrance door.

Fig. 20 shows the relationship between the wind load and the displacement at the tower top. It was found that the horizontal load suddenly falls down at the tower top displacement of 0.6m when the wind load is acting on the opposite side of the entrance door (0°) and that the ultimate bending moment was 12,540kNm.
